COLOR PHOTOS
IN NPDES FILE

10300688

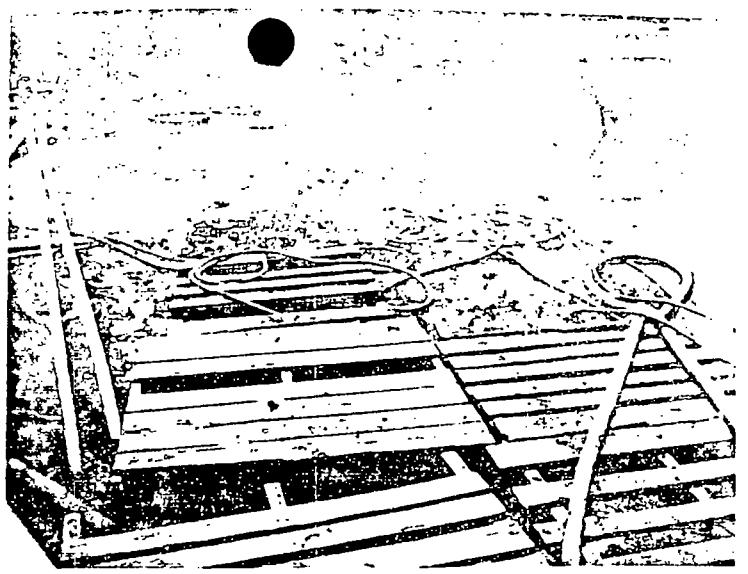
MAY 1, 1981 LOOKING SOUTH FROM E. END OF BLDG

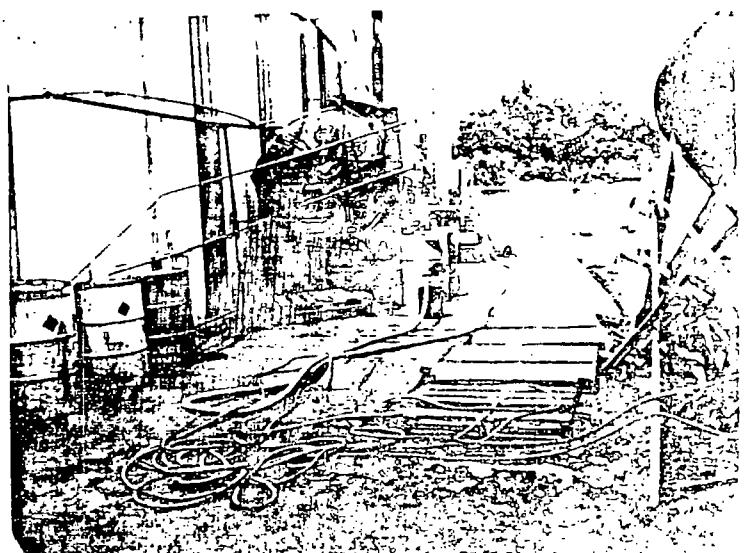
MAY 1, 1981 STILLS, EAST END OF BLDG

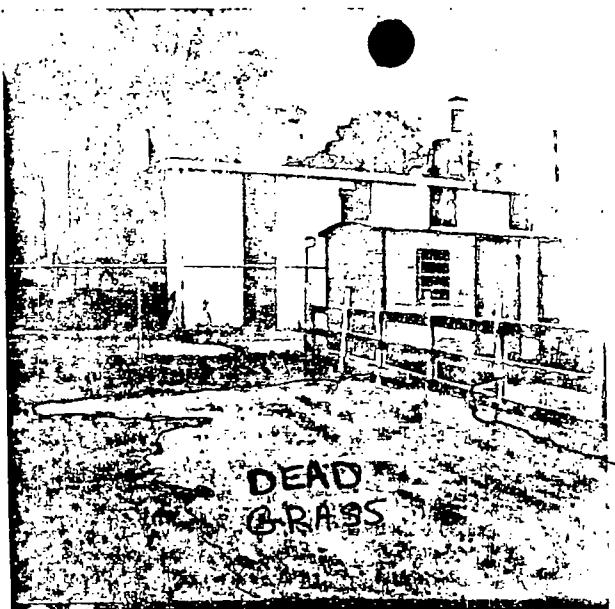
MAY 1, 1981 FROM DAVIS PROPERTY
VIEWING SOUTH TOWARD ERS

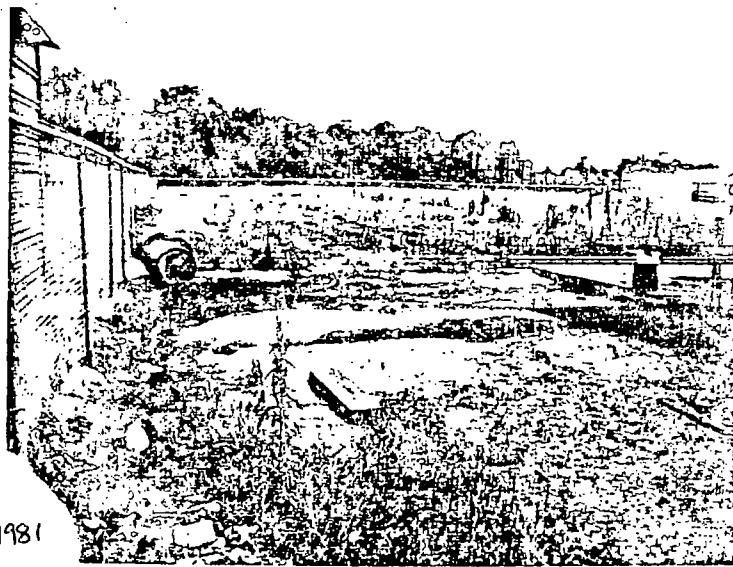
DITCH AT NE CORNER OF Building

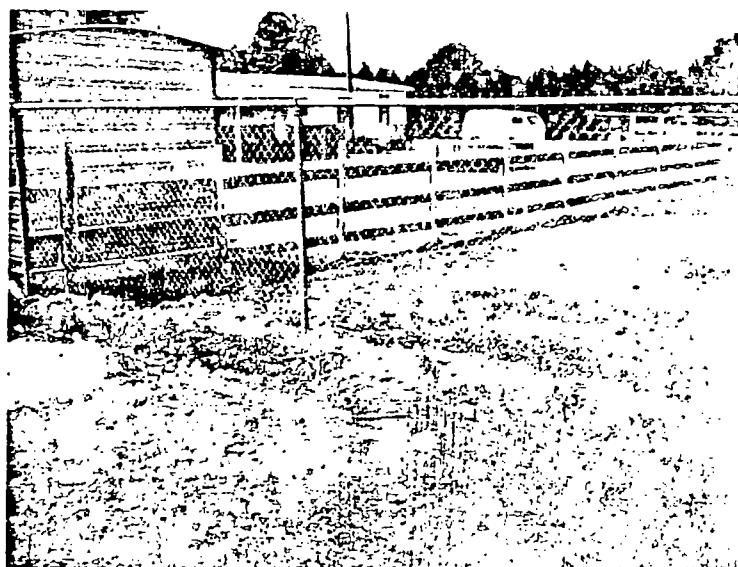
← DAVIS PROPERTY AT NE
CORNER OF BLDG.

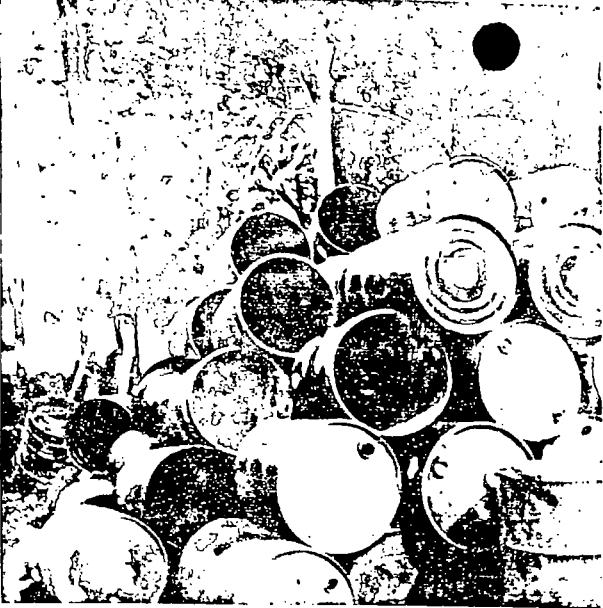
MAY 1, 1981 STORAGE AREA

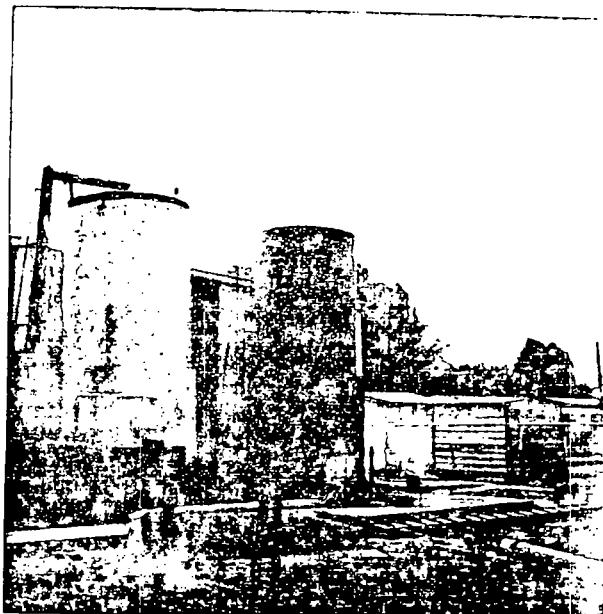
MAY 1, 1981
TANK WHICH BLEW UP (ON RIGHT)

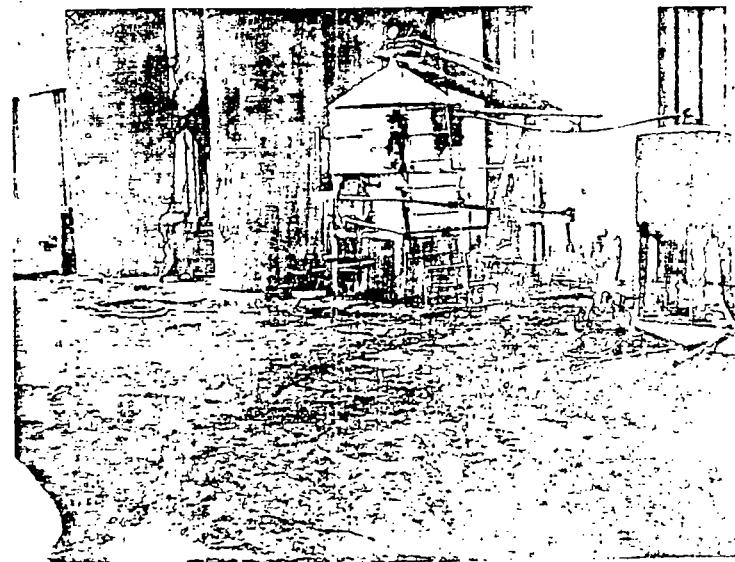
MAY 1, 1981 CLEAN MATERIAL STORAGE
FRONT OF BLDG. SOUTH SIDE
